2 Guidelines for Successful Commutator and Brush Operation

MorganAM&TTM

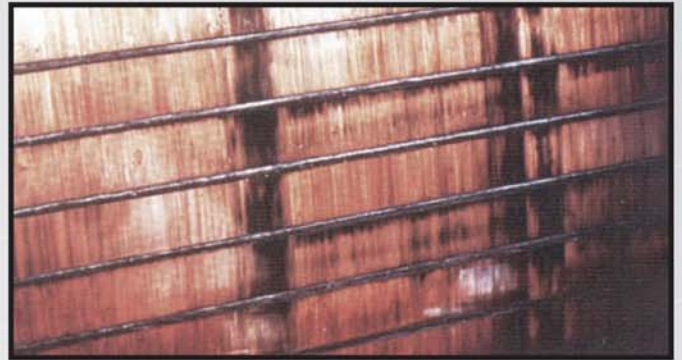
Figure 1
Streaking – Not harmful if there are just streaks in the film and the commutator is not damaged.

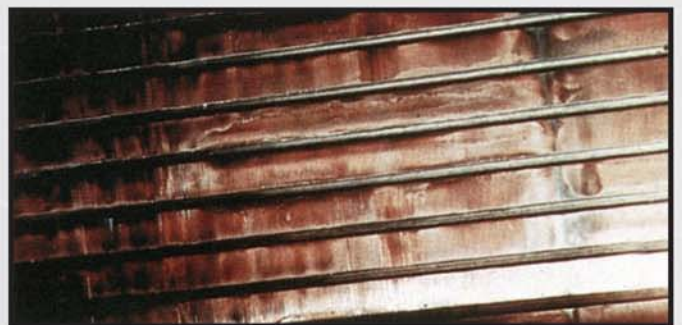
Figure 2
Mottled – Satisfactory operation can result with a film color that is not uniform.

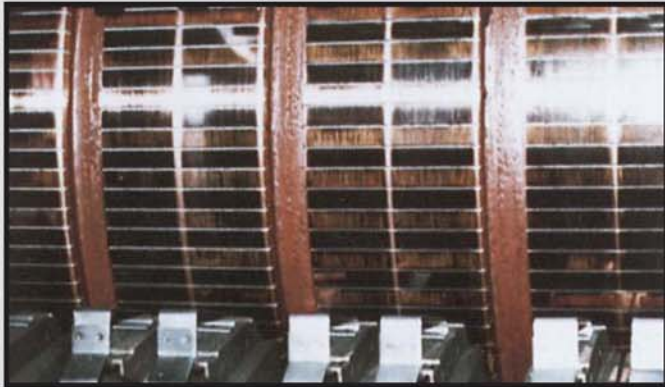
The number of conductors in the armature slot can influence commutator bar coloration resulting in a keyboard appearance or pattern. This is commonly referred to as a slot bar pattern and is characterized by every second, third or fourth bar being of a darker color than the others. Figure 3 illustrates a two-bar pattern where every second bar is darker in color. This pattern occurs in regular intervals around the commutator circumference. Slot bar patterns are related to the electrical design of the machine and are not considered harmful if the commutator has not been damaged. This is readily determined by erasing the film on darker colored bars with a pencil eraser and looking for burned or etched areas on the trailing edges.

Figure 3
Nondestructive Slot Bar Pattern. Darker film color pattern related to the number of conductors per slot.

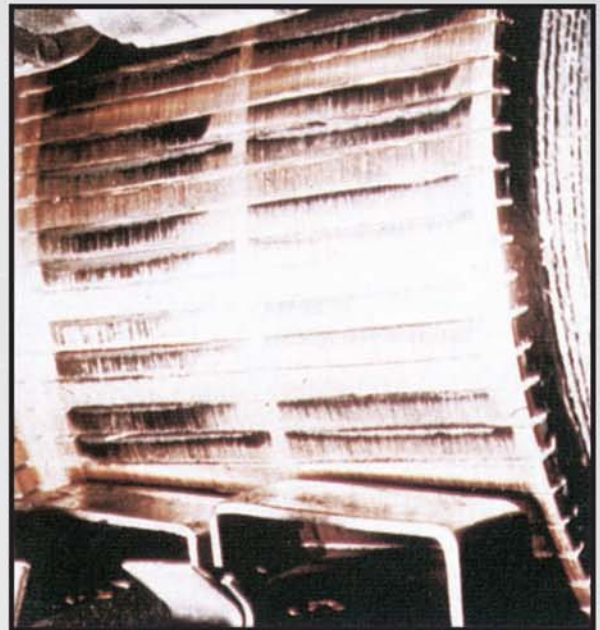
Figure 4
Slot Bar Burning – Etching on the trailing edges in a regular pattern.

Slot bar burning is influenced by factors that reduce the commutating ability of a dc motor or generator. These factors are numerous, but the most common ones can be grouped in the following three categories:

1. Use of a carbon brush material or brush design with insufficient commutating ability.
2. Improper electrical adjustment of the machine.
3. Exceeding the machine load or transient load design limits.

Where the e_R is the reactance voltage, L is the coefficient of self induction, M is the coefficient of mutual induction and di/dt is the rate of change of current with time in the short-circuited coil. High reactance voltage values increase brush circulating currents, temperatures and sparking, which can lead to slot bar burning and flashovers.

It is very important to have the correct brush material and brush design at higher reactance voltages (e_R) to maintain lower levels of brush circulating currents and associated sparking. The simplified drawing shown in Figure 5 illustrates the importance of brush resistivity in reducing circulating currents. Higher resistivities reduce circulating currents (i_c) by increasing brush cross resistance (R_B) and increasing contact drop volts (V_{C1} and V_{C2}) since contact drop usually increases as brush resistivity increases. These are reasons why higher resistivity brushes are used on the more difficult to commutate motors and generators that have elevated sparking levels that cannot be neutralized by the generated commutating pole flux voltage (V_ϕ) alone.

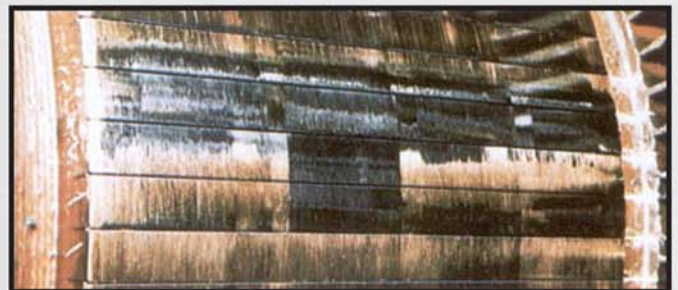
Pitch bar burning starts under the cathode brush when certain mechanical or electrical disturbances are in phase with armature rotation. Excessive arcing, metal transfer and associated burning occur every time the same commutator bars pass under the cathode brushes. Usually, the burned bars will initially be spaced at distances equal to half the number of main poles, i.e., 180° on a four pole machine, 120° on a six pole machine, etc. The commutator will develop burned areas related to the total number of poles if operation continues. Each burned area may contain one or more bars, such as shown in Figure 7, which cause the brush to bounce and eventually break if the commutator is not resurfaced.

Figure 7
Pitch Bar Burning – Commutator bar burning is a regular pattern caused by a cyclical mechanical or electrical disturbance.

At times, it is difficult to determine the cause of pitch bar burning since there are a number of possible electrical and mechanical contributing factors. Open circuit and high resistance connections in the armature circuit are leading electrical contributors. This applies to the equalizer circuit in addition to the riser/armature conductor connections. Another electrical contributor in the presence of vibration is an unbalanced main field magnetic circuit caused by shorted turns or unequal pole gaps.

Sources of vibration such as armature unbalance, worn bearings misalignment and rough or eccentric commutators are leading mechanical conditions to be considered. Insufficient brush pressure and poor riding brushes have tendency to aggravate the overall problem.

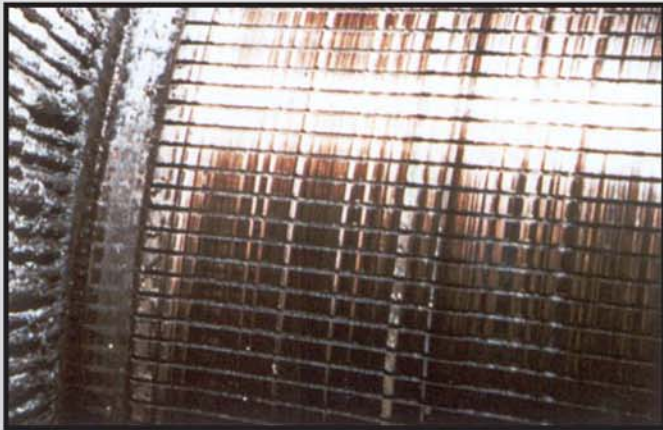
A threaded commutator is characterized by fine machined lines around the circumference that appear similar to screw threads. Threading is caused by metal transfer from the commutator to the brush face. The metal particles lodge in a porous brush material and eventually become harder (through work hardening) than the original commutator surface. The brush then acts like a cutting tool on a lathe, machine the screw-like, threaded appearance shown in Figure 8.

Figure 8
Threading – Fine machined lines in the commutator.

It is normal to experience some metal transfer to the brush face during current collection; however, most of the metal is vaporized at the higher energy levels produced when operating close to rated current loads. Operation at reduced loads lowers energy levels and allows for an excessive metal buildup in the brush face. Some corrective measures that can be taken are:

It is common to find a considerable amount of threading on commutators operating in the presence of acids, bases and some oils. Metal accumulation in the brush face is accelerated by either (1) less vaporization of contaminated metal particles because of their protective outer coating or (2) more metal being transferred because of the contaminant creating a better conductive path. Use of some graphite brush materials and treated electrographitics can help reduce metal transfer by forming a protective coating on the commutator surface. Porosity is reduced in treated electrographitic materials, but they are still prone to threading at current densities less than 45 A/in².

1. Remove some brushes to increase current density to reasonable levels in the remaining brushes
2. Use a graphite brush with less “holes” or “anchoring points” instead of porous electrographitic material
3. Use a treated electrographitic material
4. Maintain spring pressure within recommended limits.

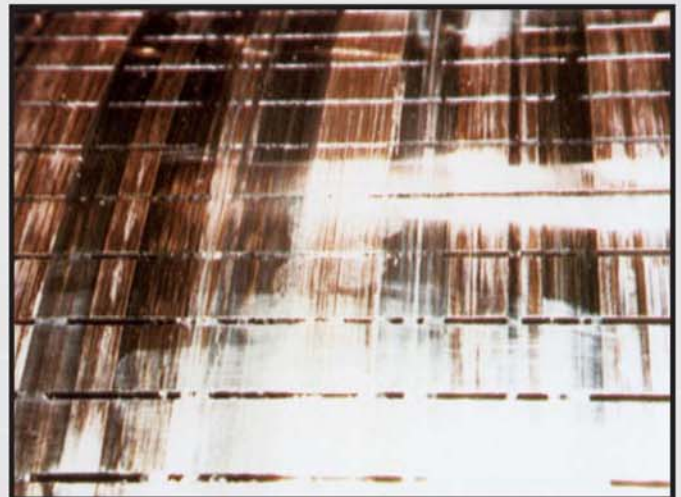
Copper drag is buildup of conductive material between commutator bars that can cause sparking and lead to flashovers when bar-to-bar voltages are significant. Copper drag is quite often associated with a combination of excessive metal transfer to the brush and environmental contamination that reduces metal vaporization. Excessive metal transfer can occur when electrical or mechanical disturbances stimulate increased sparking at the brush/commutator contact. The molten metal is formed into thin sheets by commutator rotation and brush pressure which eventually forces the flattened particles into the commutator slots. They normally adhere to the trailing edge of the commutator bar, where they build up in layers similar to that shown in Figure 9.

Figure 9
Copper Drag – Accumulation of conductive material on the trailing edges.

In general, reducing the causes for sparking and removing the contaminant will usually alleviate the copper drag. But, this is not practical in all cases and the simplest solution is to periodically clean the slots. Fortunately, copper drag is not tightly bonded to the bar edges and can easily be removed if there is sufficient access to the commutator.

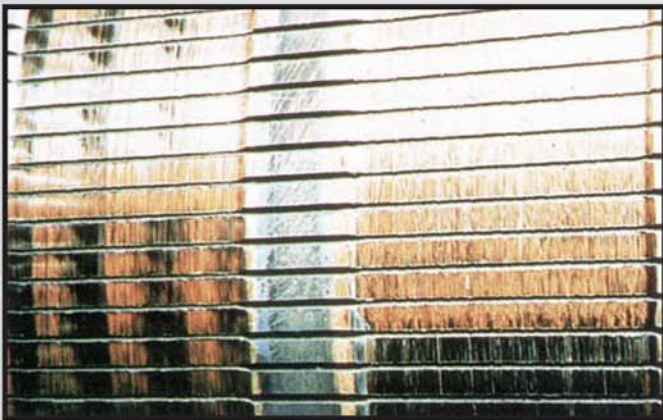
Commutator grooving usually occurs completely across the brush paths as shown in Figure 10. Groove depth may vary from path to path; however, depth in a particular path is fairly uniform around the commutator. This type of grooving is caused by either an abrasive brush or by abrasives in the atmosphere. A brush that is hard will not necessarily cause more grooving than a softer brush.

Figure 10
Grooving – Metal machined from across the brush paths.

Usually the opposite is true, for many softer brushes are made from natural graphites that inherently contain ash. Sometimes ash is added to artificial graphite brushes to control filming properties in contaminated atmospheres. Both of these natural and artificial graphite materials are soft and have a tendency toward commutator grooving. Many harder brushes (electrographitic) are baked at temperatures well over 2000°C which removes most of the abrasives that would cause commutator grooving. These electrographitic

brush materials are often treated with additives that protect the commutator by promoting the establishment of a film which reduces the chemical reactions between the contaminants and commutator copper. Much of the grooving and costly periodic maintenance is thereby eliminated by the use of treated electrographitic brushes instead of the softer graphite variety that contain ash.

On some applications, grooving caused by atmospheric abrasives can be controlled with filters or by changing equipment ventilation systems to receive cleaner air. Brush wear usually is also greater in the presence of atmospheric abrasives since both members of the rotating contact are exposed.

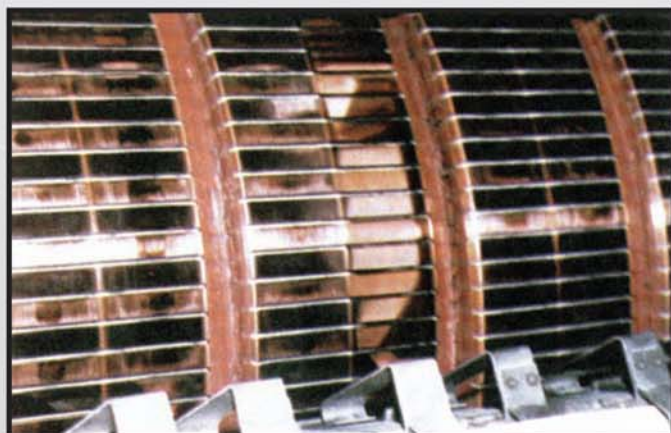
Commutator film stripping, as shown on the fourth brush path from the left in Figure 11, is quite often associated with selectivity on machines that are subjected to heavy transient loads. Film stripping promotes additional selectivity since the contact drop between brush and commutator is less on the stripped paths, resulting in a further decrease in resistivity. Brush temperatures, currents and sparking can reach extremely high levels on the stripped paths. For example, excavator generator brush temperatures of over 200°C were recorded on stripped paths while adjacent brushes on filmed paths were operating at less than 150°C. Sparking levels had reached the “streamer” stage on stripped path brushes. Cold air flow on the commutator and low humidity can further aggravate an already poor situation.

Figure 11
Stripping – Less film on the fourth brush path is a destructive condition. The slot bar pattern is acceptable since the bars are not etched.

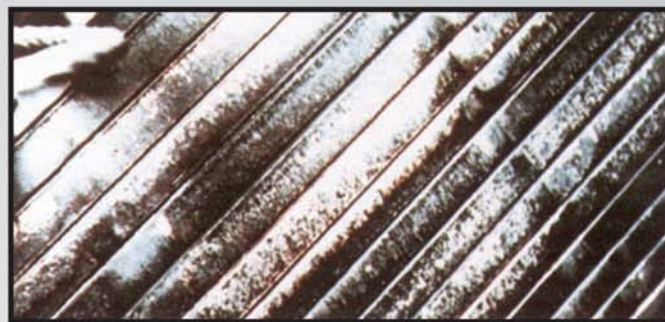
Nonconductive filming is an expression that is synonymous with the “over-filming” phrase heard quite often. Sparking and bar burning usually accompany this condition since high resistance areas in the film can be found when the commutator is probed. Nonconductive films can be formed from contamination, certain types of brush materials and sparking. Sometimes a combination of these three factors creates the unattractive commutator appearance shown in Figure 12.

Figure 12
Nonconductive Filming – Brush sparking usually results from this condition.

It is important to note that commutator film color should not be used to determine if the film is nonconductive. It is not uncommon to see very dark films on paper mill commutators that are performing quite well. This applies to other industries as well. The correct brush grade in the presence of contaminants can help provide for a successful application without costly maintenance.
